BIRD IMPACT QUALIFICATION TEST
FOR A-10 WINDSHIELD

T. L. Buchanan
Calspan Corporation/AEDC Division

April 1987

19. ABSTRACT (Continue on reverse if necessary and identify by block number)				
<p>> One shot was made on the A-10's left side windshield for this program. The objective of this shot was to qualify the windshield. The shot was at a nominal velocity of 360 knots using a 4-lb bird. Descriptions of the test facility, test articles, and test procedures are presented.</p>

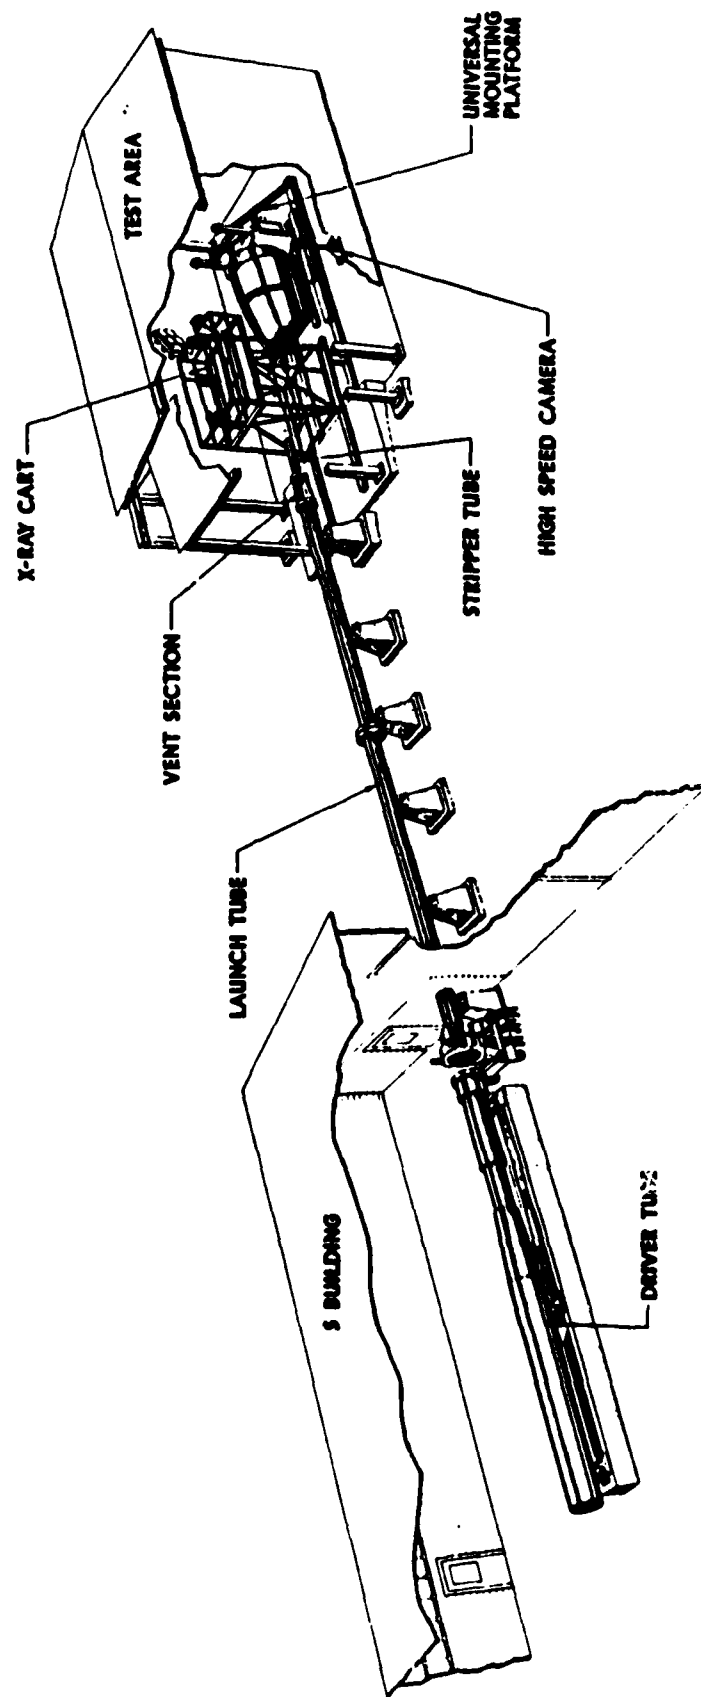
Figure 1. AEDC Birdstrike F Facility

The Range S-3 test facility is comprised of a compressed air-driven launcher, a sabot stripper, an X-ray system, a high-speed photographic system, and a universal mounting platform. The test facility and test area arrangement are shown in Figs. 1 and 2 and a detailed description of the test unit and its capabilities is contained in Refs. 1 and 2.

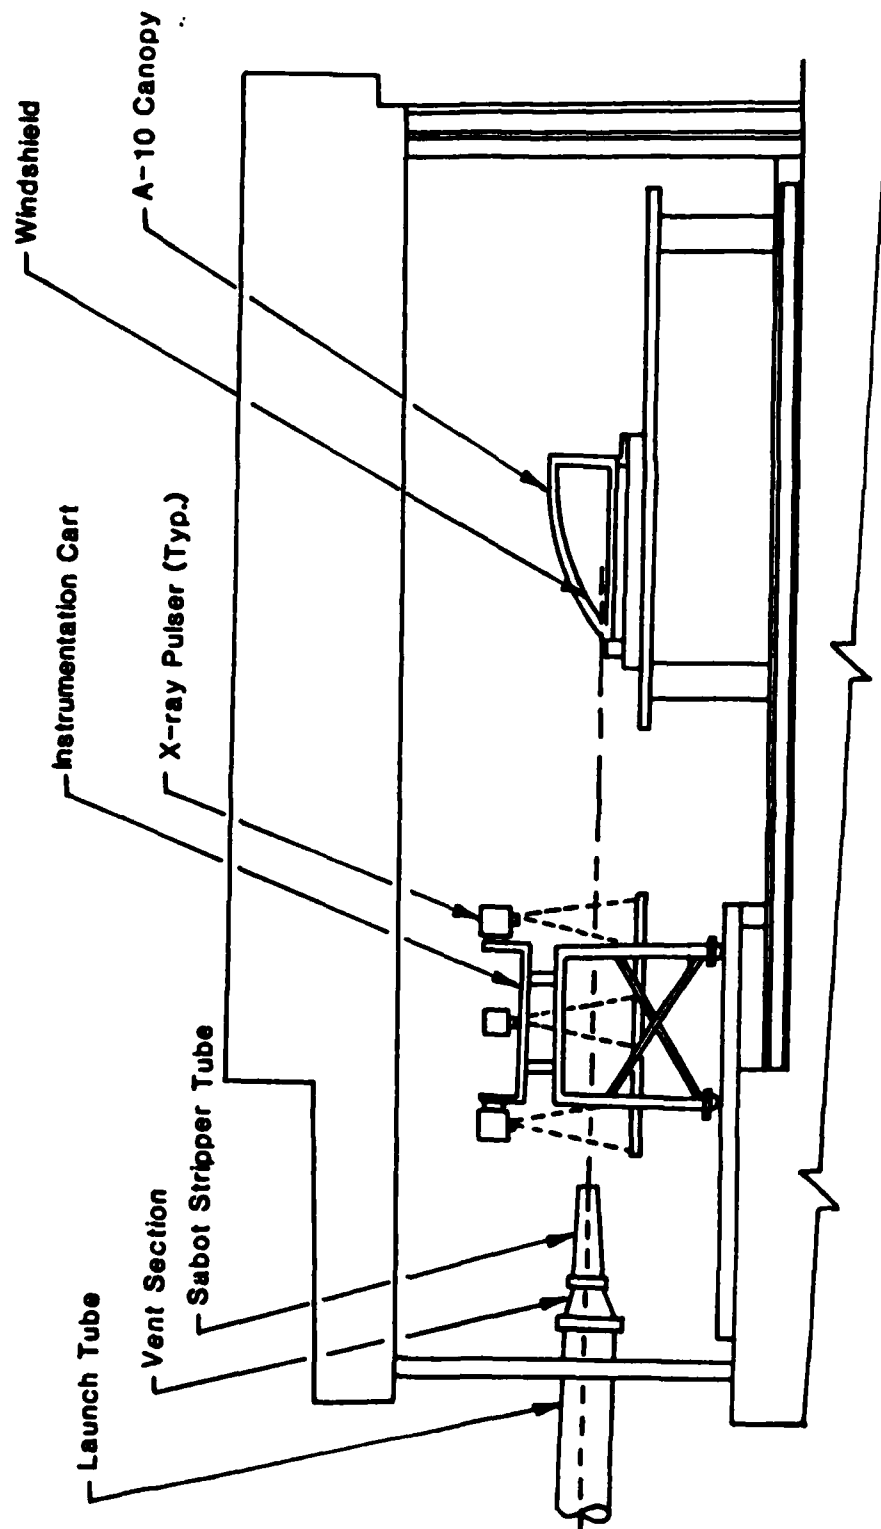
Figure 2. Test Area Arrangement

and sabot was accomplished by a tapered and grooved sabot stripper section attached to the vent section of the launch tube (Fig. 2).

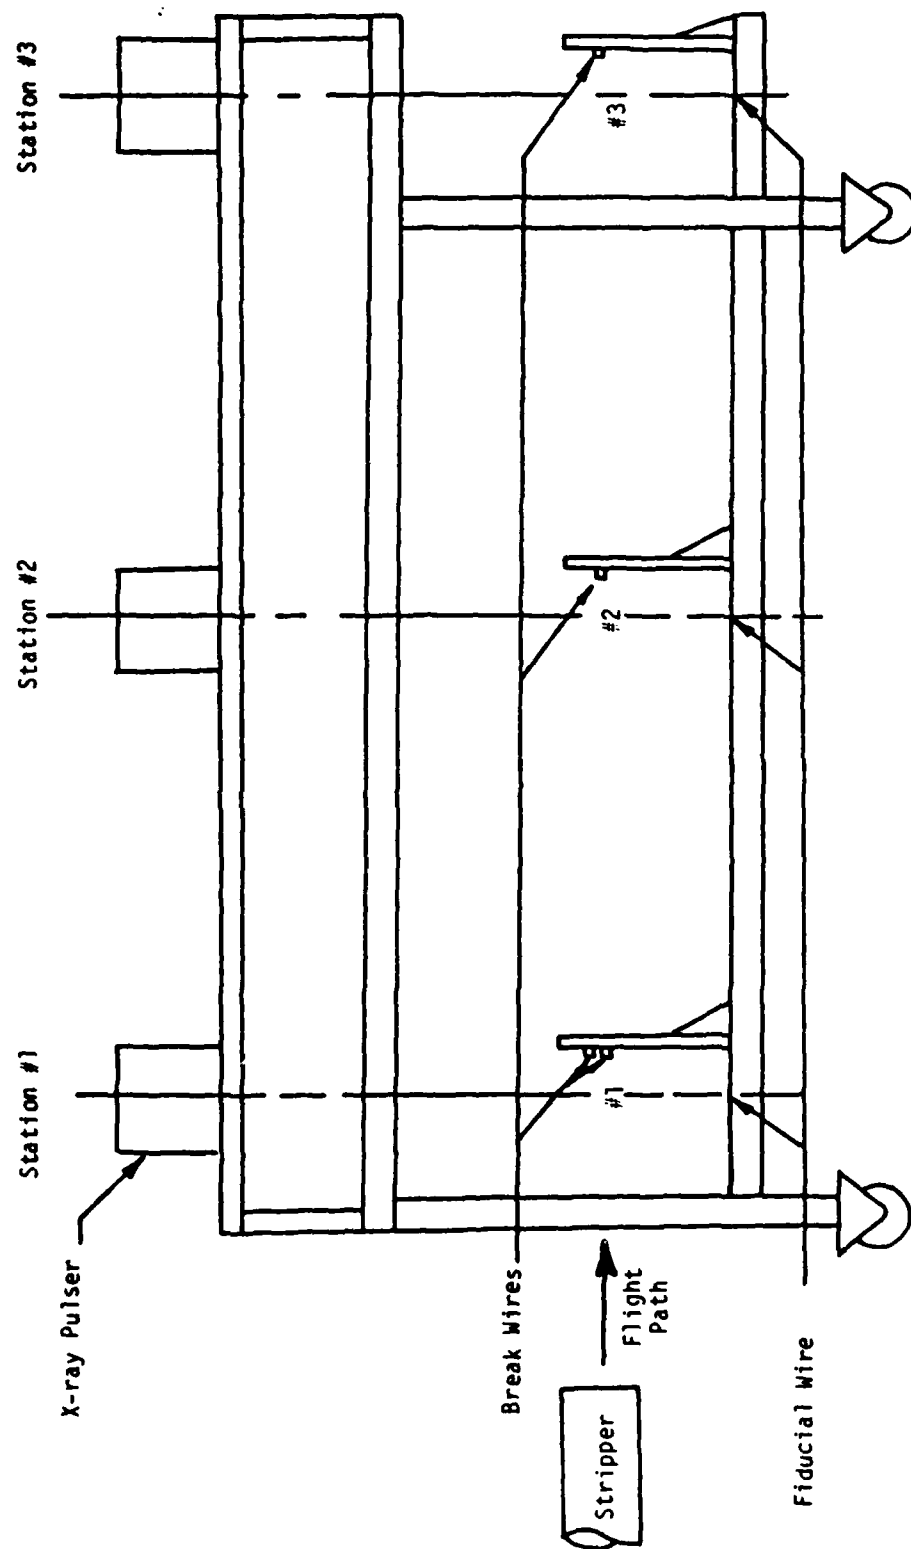
a. X-ray Cart
Figure 3. Bird Velocity Measuring System

Bird position, orientation, and velocity prior to impact were determined using the bird velocity measuring system. This system uses three 105 KV X-ray shadowgraph units and three electronic chronographs. The X-ray stations were nominally 3.5 ft apart with the first station located approximately 3 feet from the muzzle of the sabot stripper. Each X-ray pulser and electronic chronograph was triggered by a delay amplifier which was activated when the bird flew through break wires which were located under each X-ray unit (see Fig. 3).

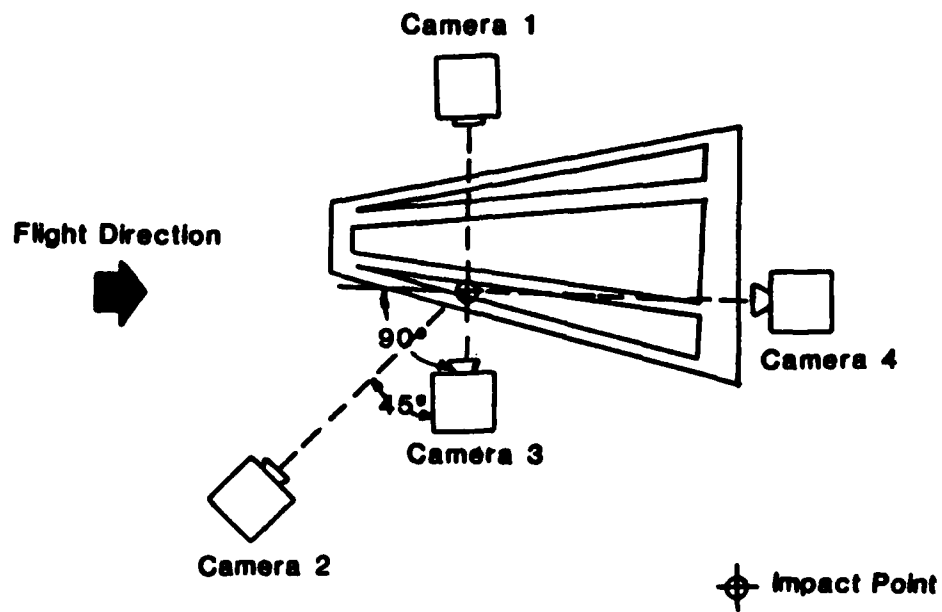
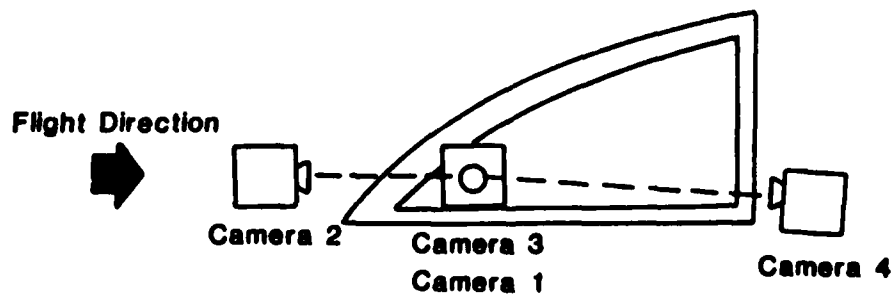
Figure 4. Camera Locations

Photographic coverage of the impact event and resulting transparency response was recorded by 16-mm motion picture cameras (Hycam Model No. 41-004) operating at 5000 frames per sec. Four cameras were used and the configuration is shown in Fig. 4. Each camera was started two seconds prior to launch and operated for a duration of five seconds. During operation, the 16-mm color film was marked with an event light (activated by the third breakwire of the X-ray system) and timing marks at 1 ms intervals providing a time base for analysis of the dynamic response.

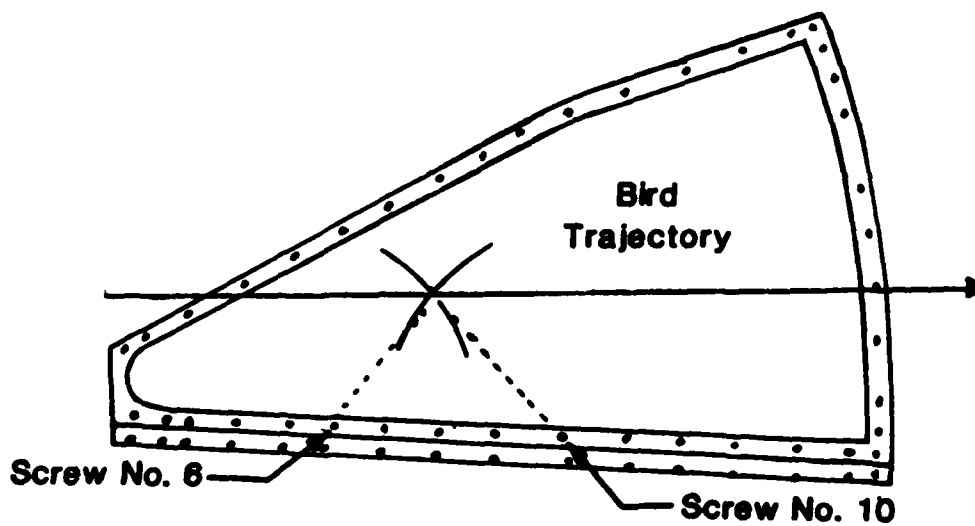
Figure 5. Bird Impact Location

Figure 5 shows the impact location used during this test. The shot was made on this location with the windshield frame at zero pitch and yaw angles. A test summary of the shot is given in Table 1.3.2

Impact point is the intersection of two arcs:

- (a) From screw no. 6, strike an 11.5-inch radius arc.**
- (b) From screw no. 10, strike a 13-inch radius arc.**
